Impact of an Epoxy Pipe Lining Material on Distribution System Water Quality

Thesis submitted to the faculty of the Virginia Polytechnic Institute and State University in
partial fulfillment of the requirements for the degree of
Master of Science in Environmental Engineering

Key words: epoxy, in situ lining material, drinking water quality

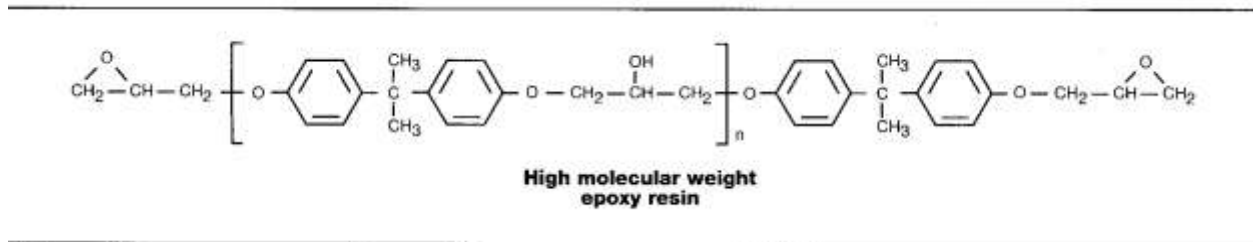
Figure I-1. Epoxy molecule containing reactive epoxy groups at each end

Figure 1 below shows a typical resin molecule, a molecule of DGEBA with reactive epoxy groups at each end.

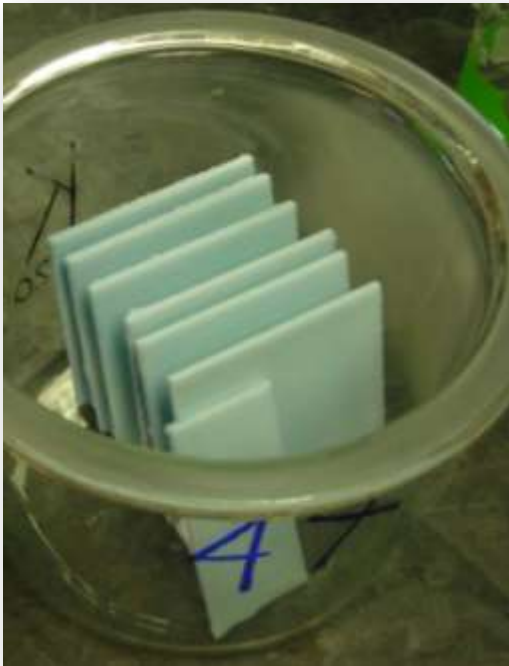
Figure II-1. Test vessel containing epoxy coupons

To perform water changes in the pipe, the pipe was filled with the same chlorinated reference water as prepared for the other samples. It was sealed on one side with a Teflon-coated rubber stopper, filled headspace free with the reference water, capped with another Teflon-coated rubber stopper, and stored in the dark adjacent to the test vessels. Figure II-1 below shows one of the test vessels containing epoxy coupons and Figure II-2 shows the epoxy-coated pipe.

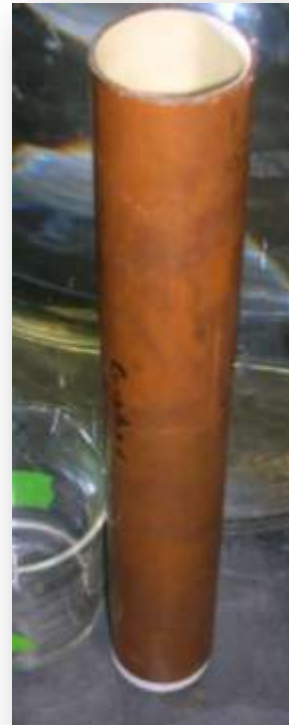
Figure II-2. Epoxy-coated copper pipe

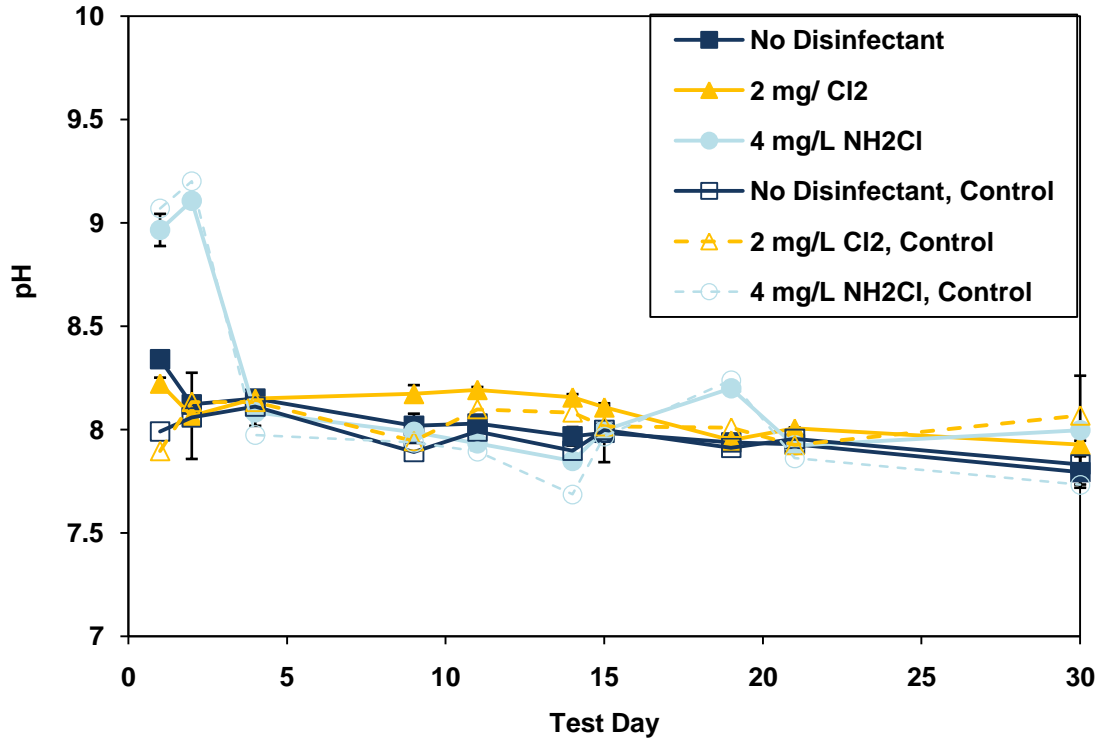
Figure II-3. pH as a function of time for all three water treatments and corresponding controls; error bars indicate standard deviations

No difference in pH was seen between any of the three water types exposed to new epoxy and their controls and no change in pH over time was found (Figure II-3). pH of the waters was shown to naturally fluctuate between 7.8 and 8.2, but these differences were generally mirrored in control samples. Upon addition of chloramines to the chloraminated test water, the pH was found to increase to approximately pH 9 and to resist initial adjustment back to pH 8.0. Following Day 2, dilute HCl was continuously added to the reference water to ensure the pH returned back to 8.0. Chloraminated water from Days 1 and 2 shows this large increase in pH (present in both test samples and controls), which is due to the addition of chloramines and is not a result of interaction with the epoxy. Statistical analysis using paired t tests confirms no statistical difference between the test waters and the controls ($p = 0.102, 0.180, 0.232$ for no disinfectant, chlorinated, and chloraminated waters, respectively). The data indicate the new epoxy lining has no effect on pH in any of the three water treatments.

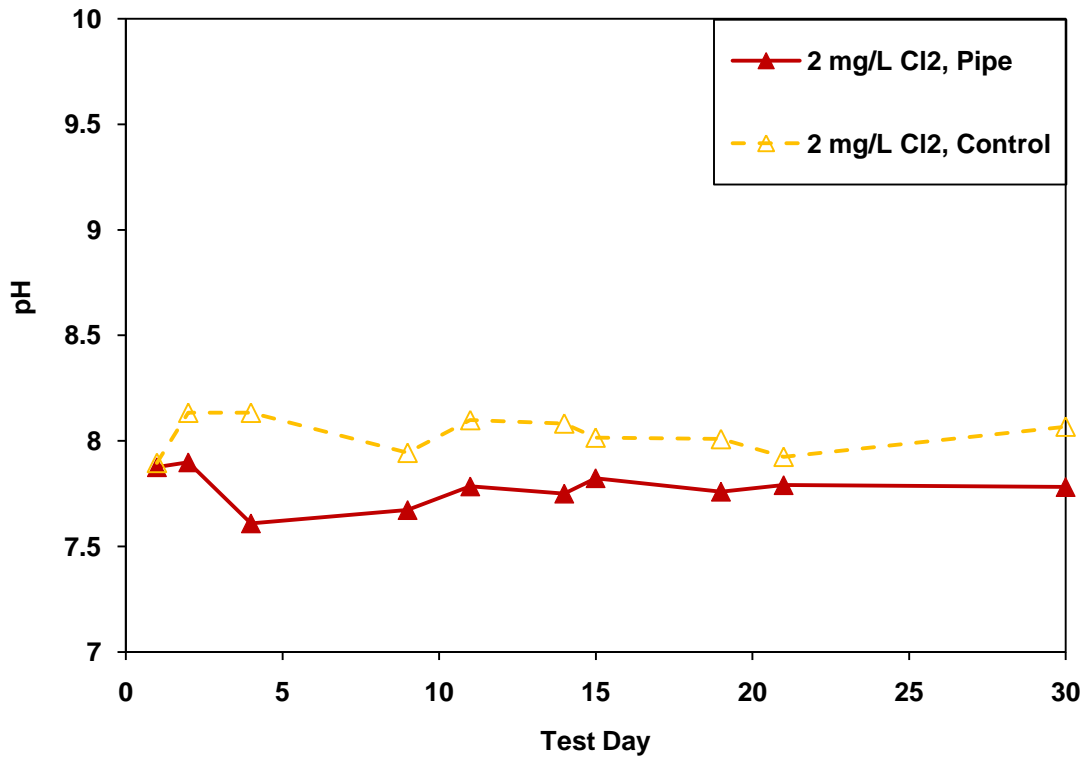
Figure II-4. pH as a function of time for chlorinated aged pipe sample and chlorinated control

For the aged pipe sample filled with chlorinated test water, the pH was shown to decrease marginally but consistently over the experiment when compared with the chlorinated control (Figure II-4). The pH dropped approximately 0.3 pH units on average, an insubstantial but statistically significant decrease when compared with controls ($p < 0.001$, one-sided t test). It is uncertain whether or not the specific formulation of the epoxy, the presence of bacteria on the surface of the lining, or another factor is responsible for the small but detectable change in pH. The results of the data are insignificant, however, because such a minor pH change would not affect water quality nor pose problems for utilities as the pH values fall within the EPA recommended range of 6.5 to 8.5 (USEPA, 2000). Overall the pH data supports the available literature that epoxy has no significant impact on pH.

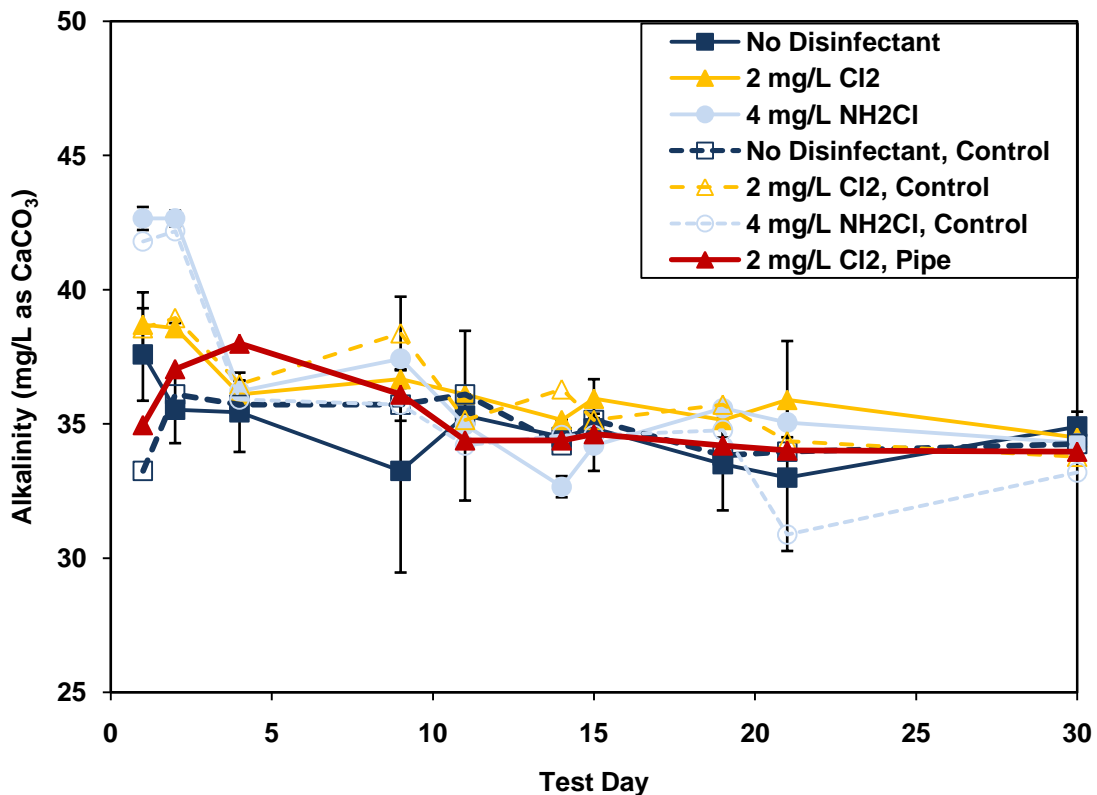
Figure II-5. Alkalinity as a function of time for all three water treatments and corresponding controls; error bars indicate standard deviations

No difference in alkalinity was detected between any of the three disinfectant treatments and their controls ($p = 0.939, 0.995, 0.599$ for no disinfectant, chlorinated, and chloraminated waters, respectively, paired t tests). The higher alkalinity readings on Days 1 and 2 in both the chloraminated test waters and chloraminated controls correspond to the higher pH readings on both days as a result of the addition of monochloramine (Figure II-5). The target alkalinity for the reference waters was prepared as 35 mg/L as CaCO_3 . Again, with the exception of Days 1 and 2 for chloraminated samples and controls, alkalinity was shown to remain within approximately 3 mg/L as CaCO_3 of the target alkalinity.

Analysis performed to compare alkalinity in the aged pipe sample to the chlorinated control also showed no difference between alkalinity in the chlorinated mature pipe sample and in the control ($p = 0.121$, paired t test). Both analyses indicate that neither the new epoxy coupons nor the aged pipe sample have any effect on alkalinity.

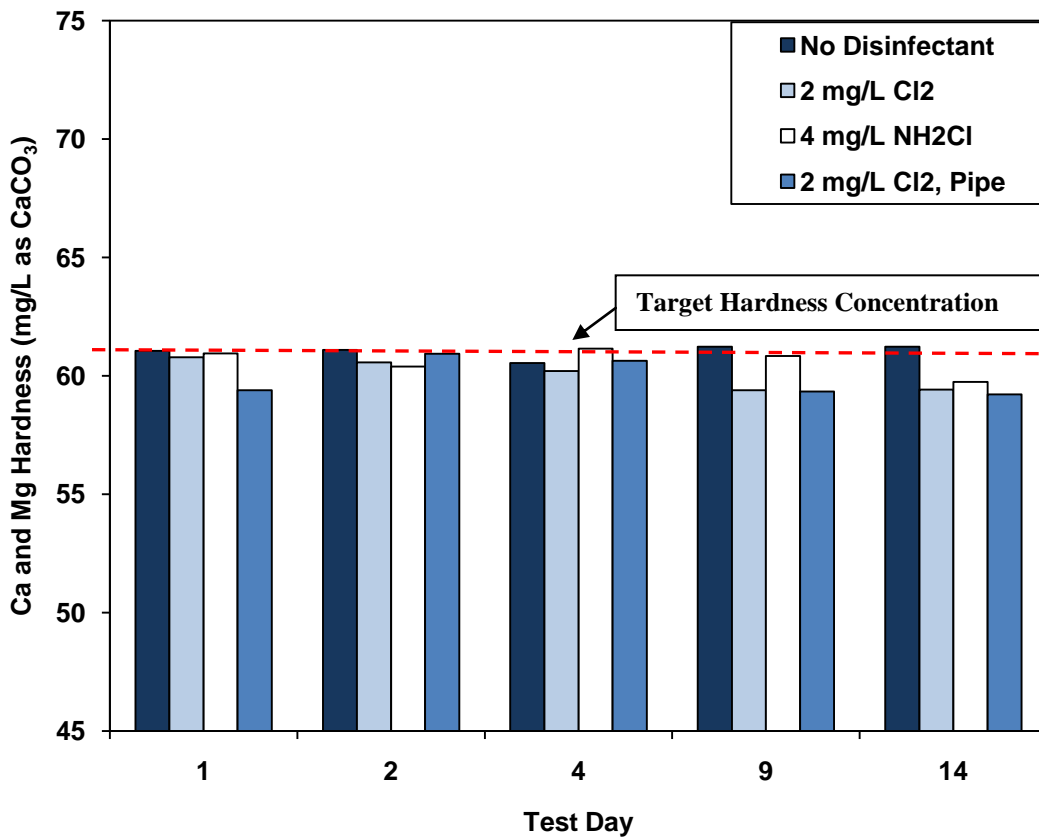
Figure II-6. Total Hardness (Ca and Mg, mg/L as CaCO₃) for all three water treatments and aged pipe sample as a function of time

No impact on hardness was seen in waters in contact with epoxy. The two primary constituents of hardness in the waters are calcium and magnesium, both added as salts to the test waters at a concentration of 11.5 mg/L Ca and 8 mg/L Mg (61.7 mg/L total hardness as CaCO₃). Hardness concentrations were identical in samples exposed to epoxy liners and controls. Data for the samples from exposed to epoxy (including the aged pipe sample) are shown in Figure II-6. Analysis using paired t tests confirms no difference between test waters and controls (p = 0.900, 0.605, 0.324 for no disinfectant, chlorinated, and chloraminated waters, respectively).

Similarly, there was no statistical difference in hardness between the aged pipe sample and the chlorinated control (p = 0.439, paired t test). Neither new nor aged epoxy was shown to have an impact on total hardness. These results were expected. (Controls are not shown but also showed no deviation from the target alkalinity of 61.7 mg/L as CaCO₃.)

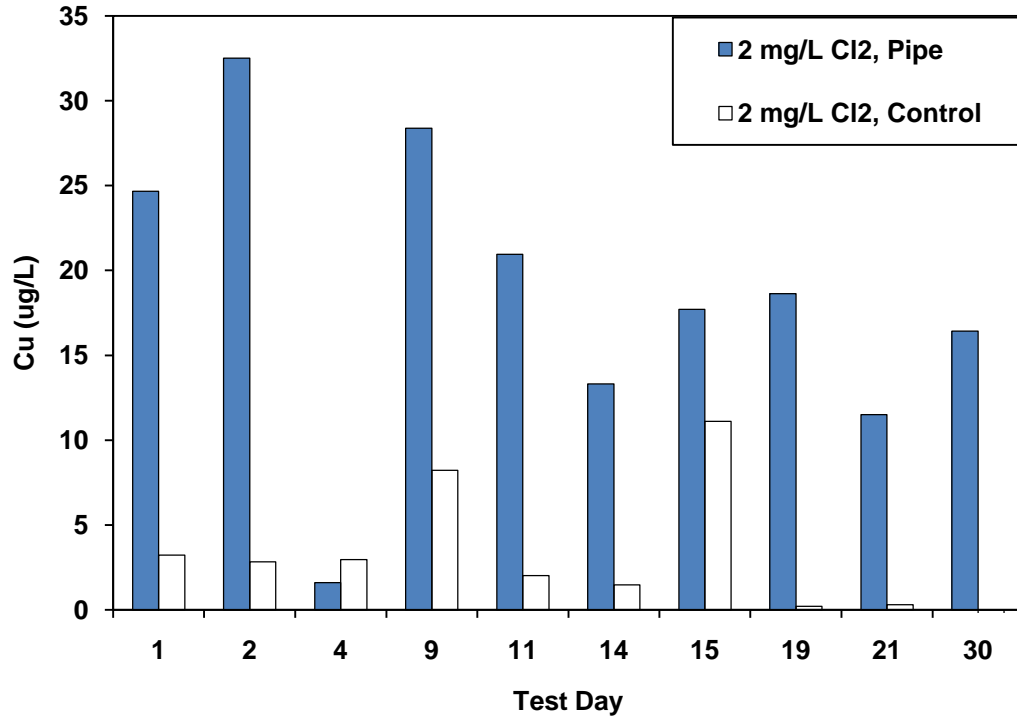
Figure II-7. Copper concentrations (ug/L) in aged pipe sample and chlorinated controls as a function of time

With the exception of copper, analysis comparing metals and nonmetals concentrations in the aged pipe sample to its chlorinated control also failed to detect a statistical difference between any of the elemental concentrations ($p > 0.05$ for all tests). Copper concentrations in the aged pipe ($< 35 \text{ ug/L}$ on all test days) were shown to be significantly higher than in controls ($p = 0.00016$, paired one-sided t test) which is almost certainly due to either copper filaments that were stuck to the epoxy layer after the pipe was cut or exposure to the pipe edges (Figure II-7). Inspection of the epoxy layer revealed no holes, tears, or failure that would result in copper released from the pipe wall itself. Other than copper present in the aged sample, both new and aged epoxy were not found to have an effect on selected metals or nonmetals concentrations in the water. These findings were expected, as epoxy is used as a corrosion preventative that is meant to decrease metals concentrations in water scoured from pipe walls.

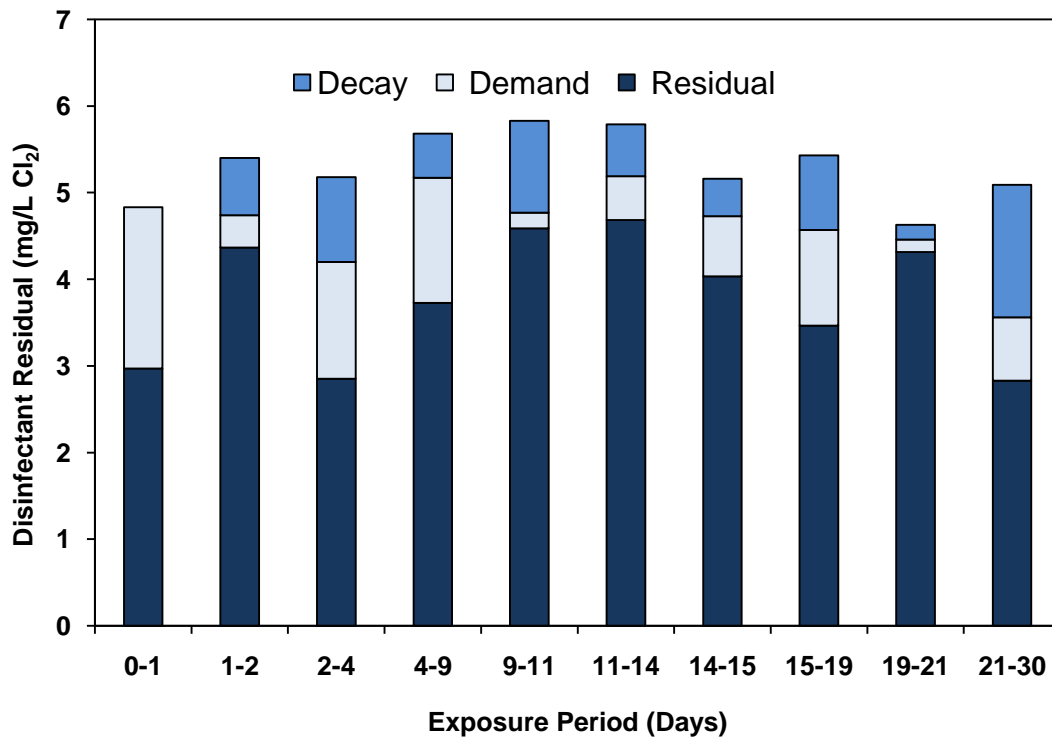
Figure II-9. Fate of monochloramine, showing disinfectant residual, disinfectant consumption, and natural disinfectant decay (as measured in controls) as a function of time

Chloraminated water exposed to new epoxy also exhibited higher demand than controls but the chloramines residual present in the water was much greater than for free chlorine (Figure II-9). The first 24 hour exposure period showed high disinfectant demand, with a 32% decrease in monochloramine from 4.4 mg/L to 3.0 mg/L. (By contrast, the control showed no decay). After this first exposure, however, there was an observable decrease in demand and by the end of the study the consumption after 9 days of exposure was only 0.7 mg/L. Consistent with the literature, chloramines exhibited a greater stability in the water and maintained a higher residual and overall lower demand over the 30 days.

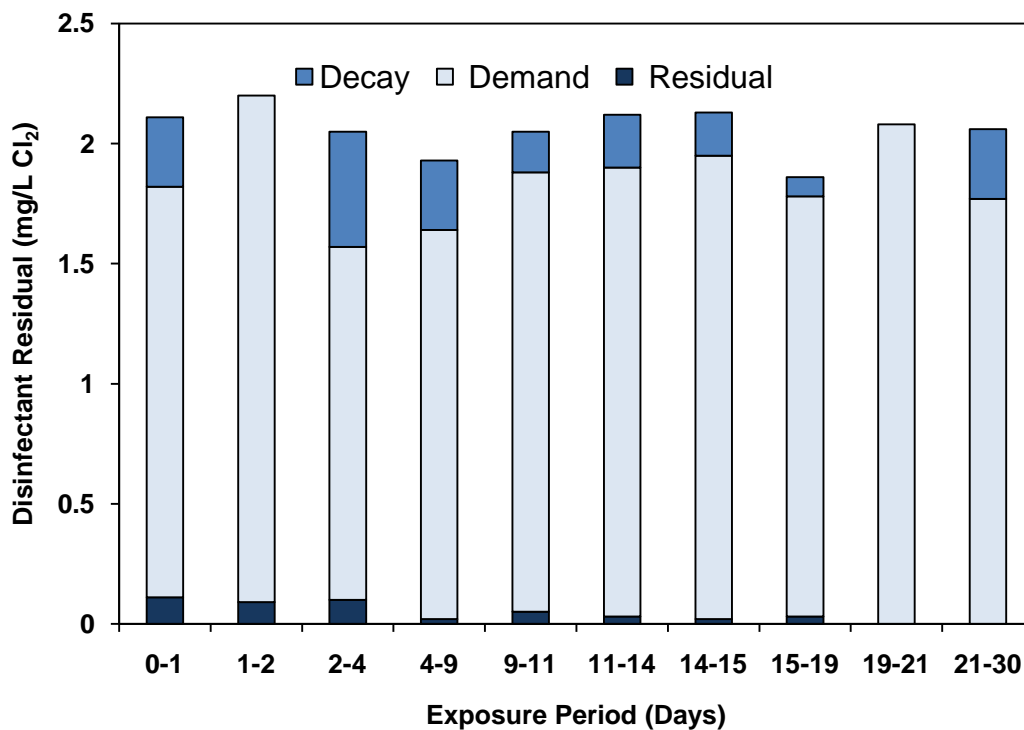
Figure II-10. Fate of chlorine decay in the aged pipe sample, showing disinfectant residual, disinfectant consumption, and natural disinfectant decay (as measured in controls) as a function of time

Figure II-10 show the disinfectant loss in mg/L as Cl₂ for both chlorinated and chloraminated waters. (The no disinfectant treatment water is not shown, as there was no detectable free or total chlorine in the initial reference water or at any point during the study.) The data were consistent with the literature in showing that exposure to epoxy results in high disinfectant demand, with notably higher consumption of free chlorine than monochloramine occurring. Because maintaining a disinfectant residual of at least 0.2 mg/L at the tap is necessary for utilities, they should be aware of the potential problems faced with lining pipes with epoxy in chlorinated drinking water systems, particularly if those portions of the distribution system are in dead-end zones where stagnation is allowed to occur.

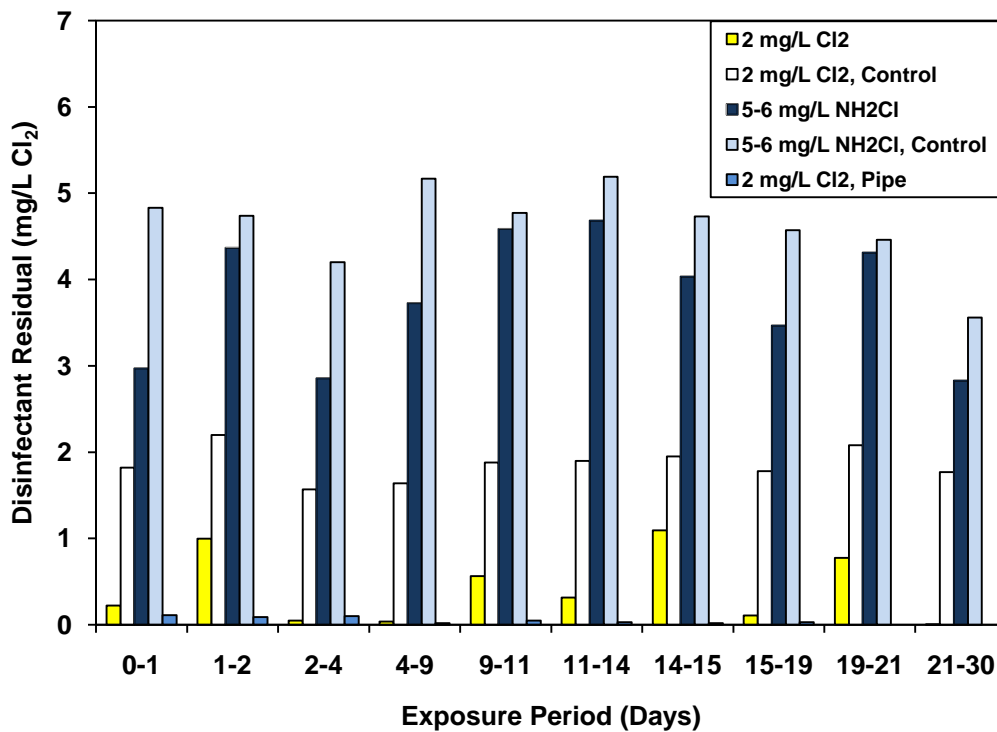
Figure II-11. Chlorine and monochloramine residuals (mg/L Cl₂) in new and aged epoxy samples and controls, as a function of time

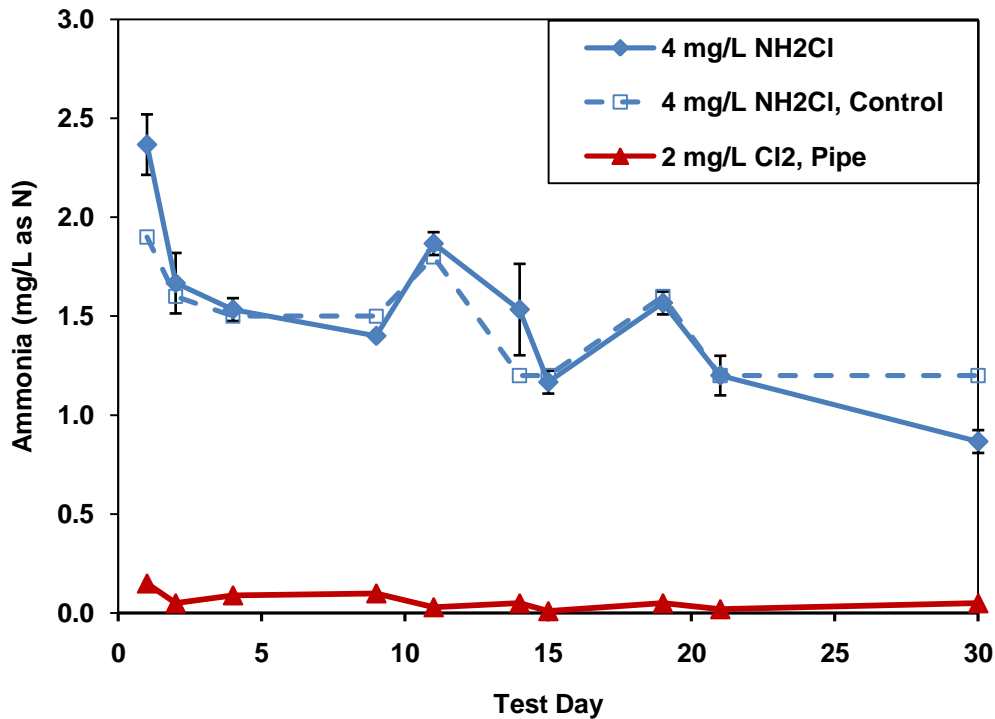
Figure II-12. Ammonia (mg/L as N) in chloraminated sample and control waters (4 mg/L NH₂Cl), as a function of time

No significant changes were seen in ammonia concentrations in reference waters upon exposure to epoxy. Neither the no disinfectant water nor the chlorinated water had ammonia levels above background levels so Figure II-11 shows only ammonia concentrations in chloraminated water. The figure shows similar concentrations of ammonia in both the sample and control waters and statistical analysis using paired t tests showed no difference between the N-NH₃ concentration in the chloraminated test waters and controls ($p = 0.522$). This is understandable in that ammonia in equilibrium with free chlorine would be measured as ammonia in the water. Interestingly Day 1 did have a measurable difference in ammonia of approximately 0.6 mg/L as N. As the concentrations of ammonia in no disinfectant waters and chlorinated water had no detectable concentrations released from the lining, it's likely the difference is attributable to the monochloramine and its equilibrium products. It is possible that the high monochloramine demand on Day 1 in samples exposed to new epoxy released free ammonia into the water and caused there to be a higher reading of ammonia for those samples. Other than the higher concentration detected on Day 1, epoxy had no discernible effect on the concentration of ammonia in the water.

Also of note is the trend seen in the ammonia concentration in the mature pipe sample. The concentration of ammonia, while very low, was consistently and significantly higher than the concentration in the chlorinated control waters ($p = 0.0004$, paired t test). The slightly higher concentration of N-NH₃ found in the pipe samples, which averaged 0.06 mg/L over the course of the study (compared with 0.00 in the control), could possibly be due to the presence of bacteria on the surface of the epoxy. Given the low oxygen conditions present in the pipe, heterotrophic bacteria (which were detected on the lining) could have dissimilated nitrate added to the water as KNO₃ back into ammonia. The low concentrations of 0.06 mg/L of ammonia, however, are unlikely to negatively affect water quality in any measurable way.

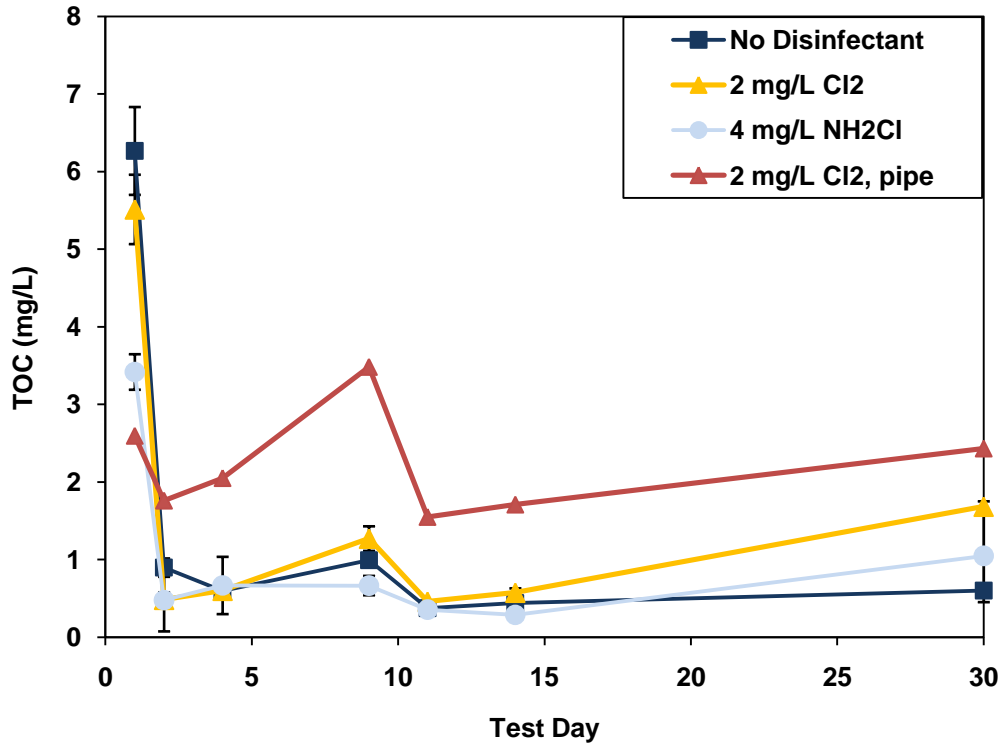
Figure II-13. TOC (mg/L) as a function of time for all three water treatments and aged pipe; errors bars indicate standard deviations

The concentration of TOC in the aged pipe sample (mg/cm^2 surface area) exposed to chlorinated water was significantly higher than was expected, given that the sample had been in service for four years. TOC was lower on Day 1 (2.6 mg/L) than in waters exposed to new epoxy but was higher than new

epoxy than all other test days. Because the sample was four years old, it is unlikely that the TOC in the water was due entirely to organic carbon leached from the epoxy, as leaching rates as high as those detected in the aged pipe samples would most likely be too great for the lining to still be intact. Rather, it is probable that a substantial portion of the TOC is from biomass present on the surface of the epoxy lining. The presence of heterotrophic bacteria on the lining is almost certainly a source of much of the TOC detected in the samples.

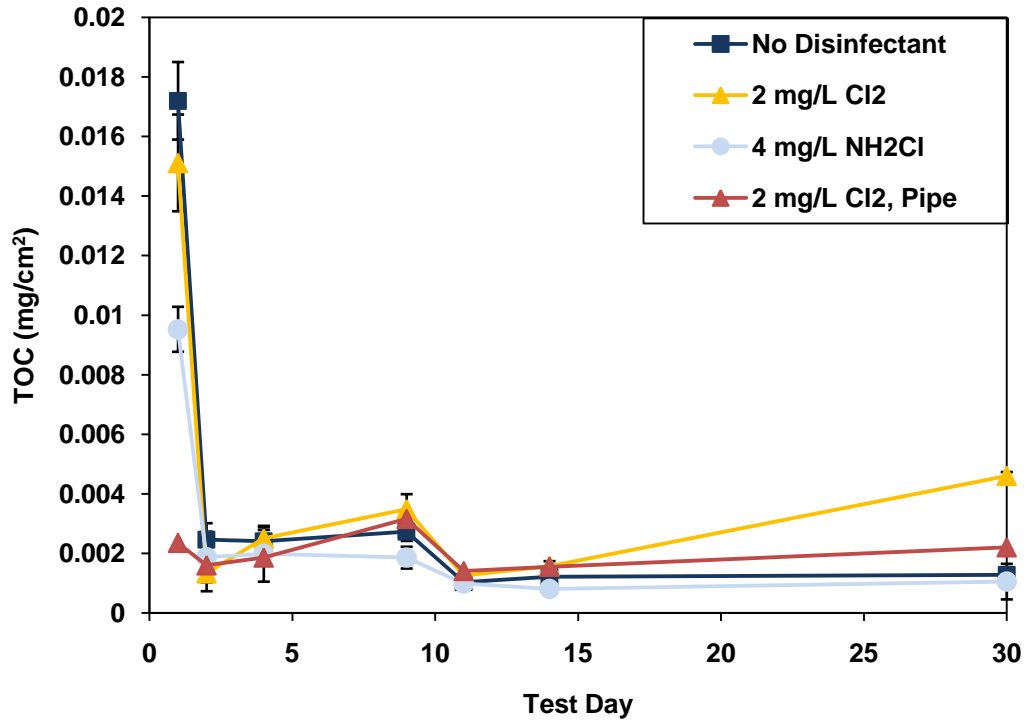
Figure II-14. TOC (mg/cm²) as a function of time for all three water treatments and aged pipe; error bars indicate standard deviations

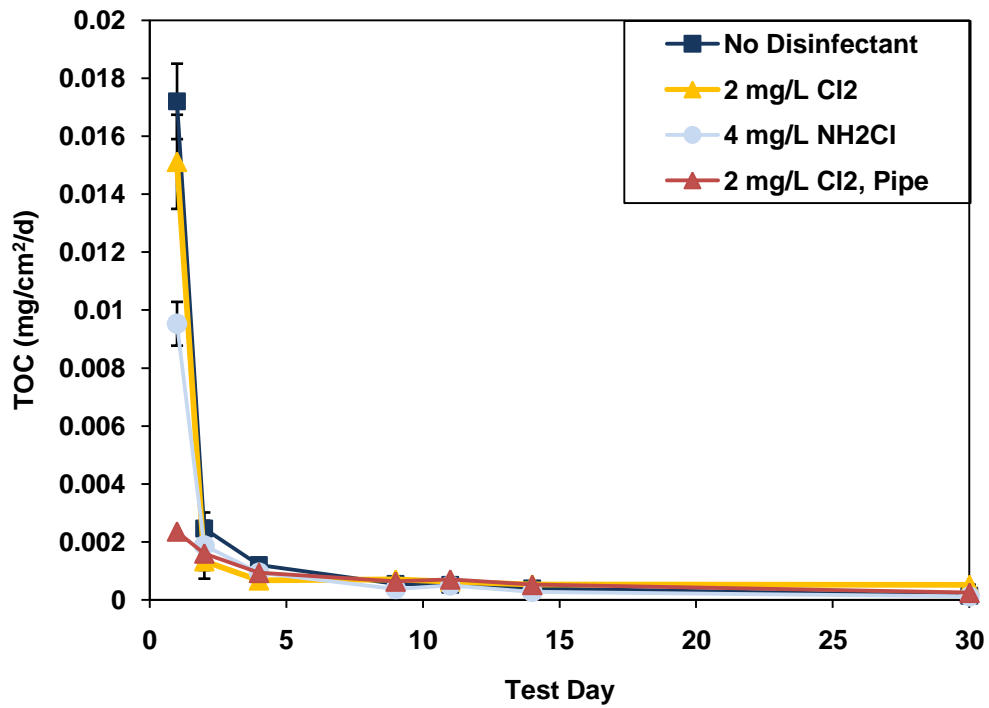
Figure II-15. Rate of TOC leached (mg/cm²/d) as a function of time for all three water treatments and aged pipe; errors bars indicate standard deviations

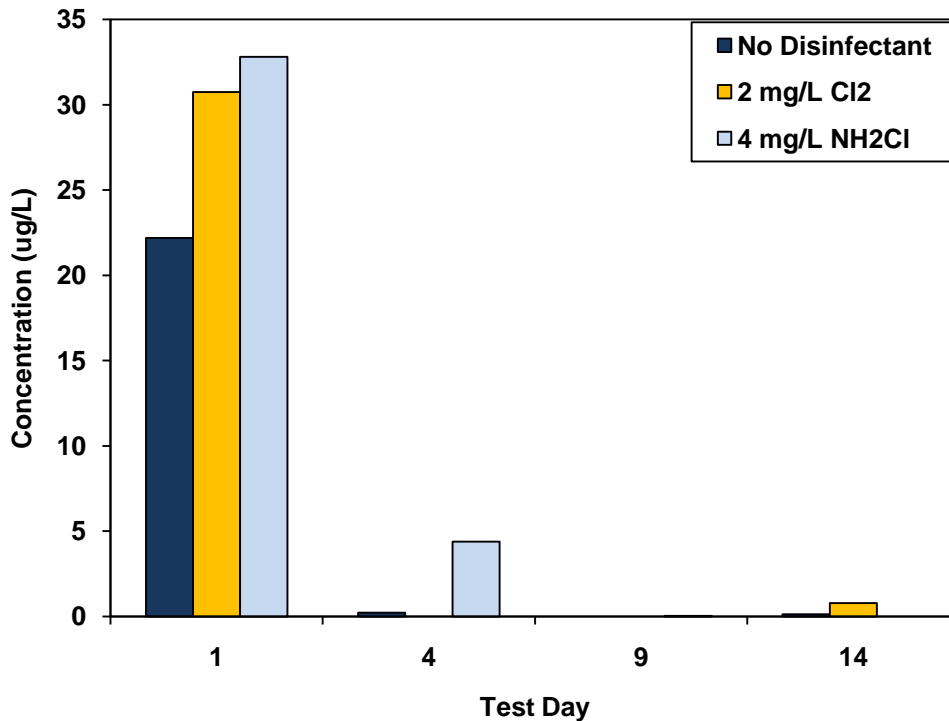
Figure II-16. Bisphenol-A concentrations (ug/L) for all three water treatments as function of time, corrected for controls

Bisphenol-A (BPA) was detected on three separate sampling days. Concentrations (22-33 ug/L) were highest during the first exposure period and decreased significantly on later sampling days. Concentrations of BPA were detectable in controls on some of the days but, with the exception of one sample, were always lower than concentrations in samples exposed to epoxy. Figure II-15 shows the concentrations in waters exposed to the epoxy samples less the concentrations in controls. BPA levels were the highest in chloraminated water and lowest in no disinfectant water, the exact opposite trend of TOC concentrations. As Bae et al (2002) reported a correlation between BPA and COD, these results were somewhat surprising. However, given that the concentrations were extremely low and only differed by 11 ug/L, the numbers most likely don't show any significant trend. These initial concentrations were notable but not alarming by drinking water standards, as the total allowable concentration (TAC) for BPA as recommended by ANSI/NSF-61 is 200 ug/L (ANSI/NSF-61, 2000). By Day 4 the levels had fallen substantially and they remained very low to non-detectable for the remainder of the study. The aged pipe was not sampled for BPA due to the smaller water volume of the pipe. As there was significant TOC leaching in the aged pipe, there is potential for BPA to be leached as well and future studies comparing BPA in aged and new epoxy might be useful. Judging from the existing data for new epoxy linings, there do not appear to be major water quality impacts from BPA, particularly under normal flow conditions.

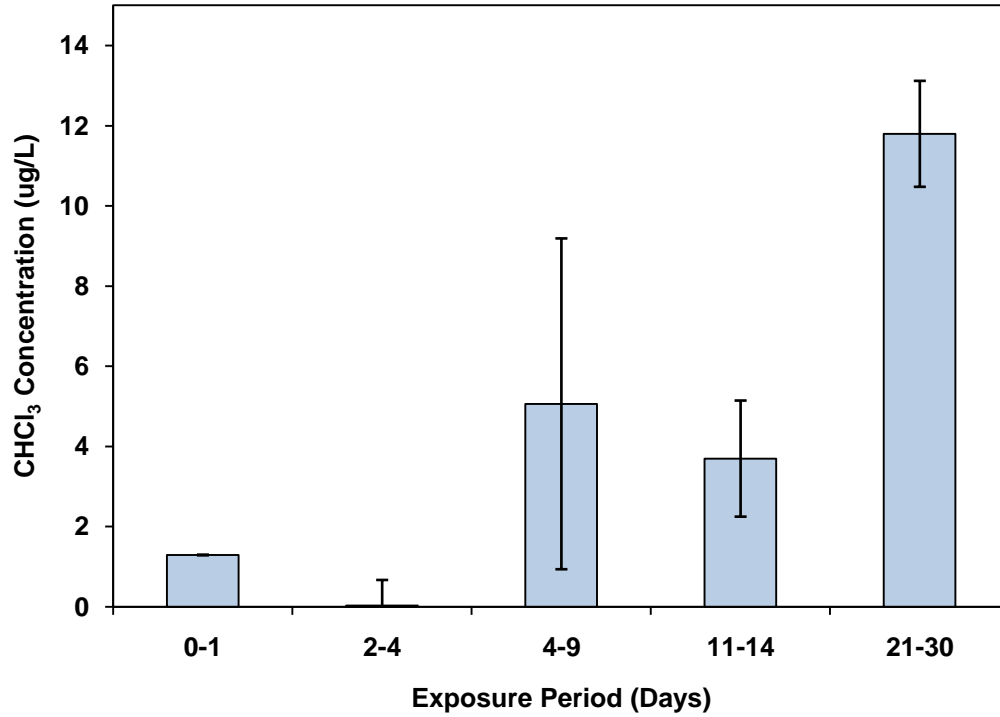
Figure II-17. THM concentrations (ug/L, Chloroform) in chlorinated samples exposed to new epoxy; error bars indicate standard deviations

Even though CHCl_3 concentration detected in the water is significantly lower than the MCL for total THMs, the data confirm earlier studies that show epoxy does react with disinfectant present in the water (particularly free chlorine) to produce detectable levels of CHCl_3 . However, given that high disinfectant consumption occurred and high concentrations of TOC were leached, the low concentrations of THMs detected suggests that the TOC leached from epoxy linings does not readily produce THMs. Also, considering that the study was performed under stagnant conditions at a high surface area to volume ratio, it is suspected that THM formation will not be a major problem for epoxy linings.

For Figures II-17 and II-18, the sample size on Days 1 and 2 was lower due to sample loss. Therefore only one sample was available on Day 1 and two samples on Day 2. This low sample size and the relatively high error bars depicted in the two figures thus warranted performing another experiment to confirm the validity of the data. This experiment, described in the following section, also examined the relationship between free chlorine consumption by TOC leached from epoxy and the concentration of THMs formed. After normalizing these results for surface area to volume ratio, the concentration of CHCl_3 detected fell within the same range as that present during the earlier immersion study, giving further credence to the data.

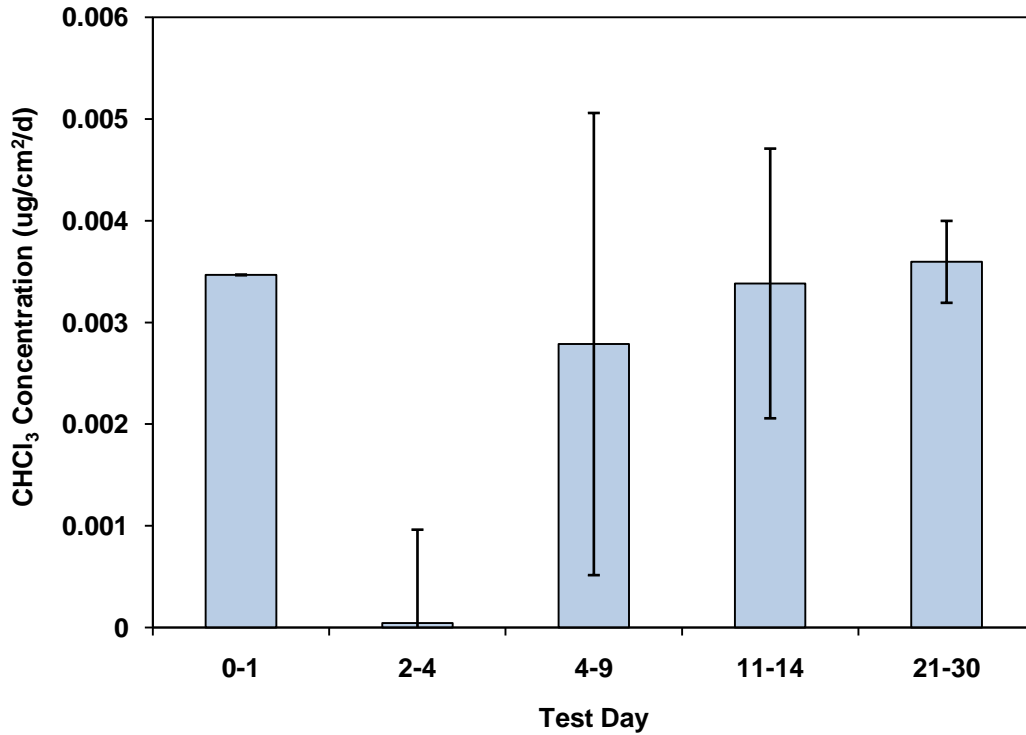
Figure II-18. THM formation rate (ug/cm/d, Chloroform) as a function of time in chlorinated samples exposed to new epoxy; error bars indicate standard deviations

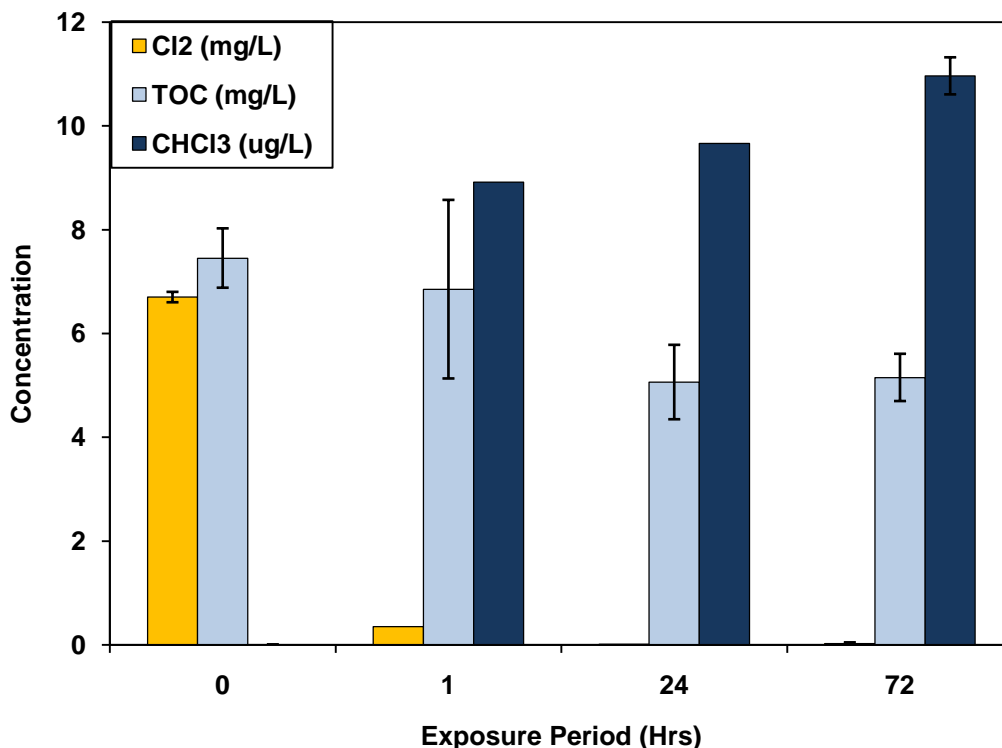
Figure II-19. Concentrations of disinfectant residual (mg/L), TOC (mg/L), and THMs ($\mu\text{g/L}$) as a function of time after exposure to 6.7 mg/L chlorine

Some of the data was surprising, however. First, significantly higher disinfectant levels (6.7 mg/L compared with 2 mg/L) combined with higher TOC concentrations did not result in significantly increased THM formation. Presumably higher disinfectant levels coupled with higher TOC would have resulted in increased concentrations of CHCl₃. Also unexpected was the decrease in TOC seen across the three days. TOC decreased from an initial high of 7.5 mg/L to 5.1 mg/L. Although this decrease was

consistent in all samples it was not well understood. Finally, the slight apparent increase in CHCl_3 from 9.7 to 11.0 $\mu\text{g/L}$ after 72 hours could not be explained by the residual and is likely due to statistical variability, as all chlorine had been consumed after 24 hours of exposure. Figure II-19 shows the results of the study.

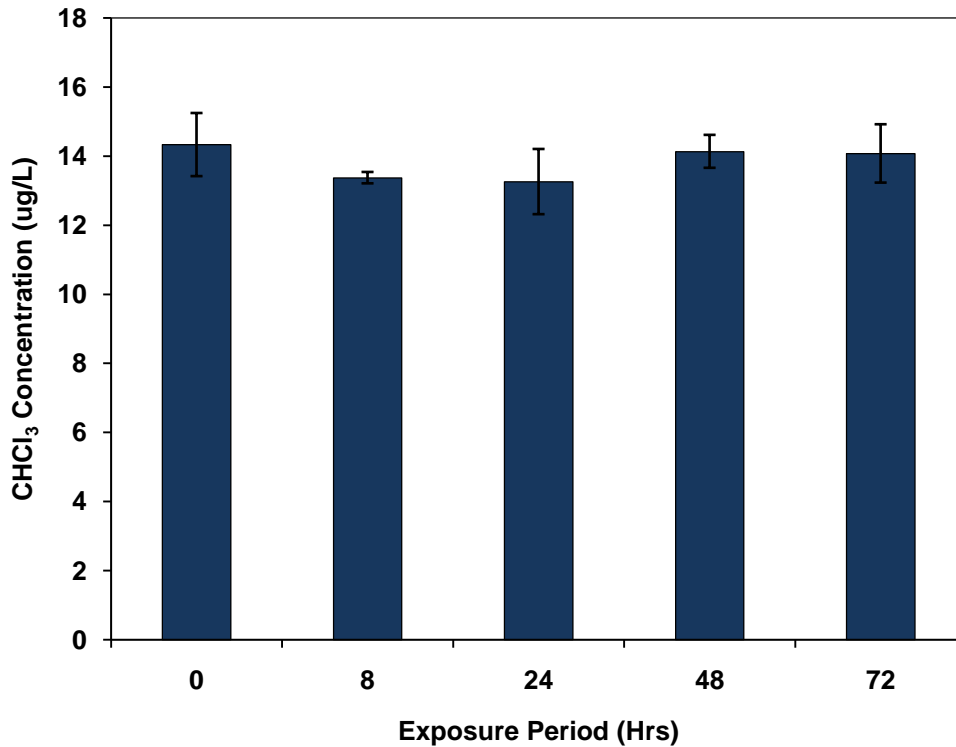
Figure II-20. CHCl_3 concentration (ug/L) in waters spiked with 14.5 ug/L CHCl_3 as function of exposure time (hrs)

This experiment was performed under the same test conditions and again used new epoxy-coated coupons. 10 coupons were exposed to no disinfectant reference water spiked with approximately 14.5 $\mu\text{g/L}$ of CHCl_3 . Samples were collected from the headspace-free vessels after 8, 24, 48, and 72 hours to determine CHCl_3 concentration in the samples. After analysis the concentration of CHCl_3 in the samples remained constant and there was no statistical change in CHCl_3 observed over the 72 hours ($p = 0.689$,

linear regression) (Figure II-20). Thus epoxy does not absorb CHCl_3 and all THMs formed from the chlorination of organic carbon were likely still present in the water.

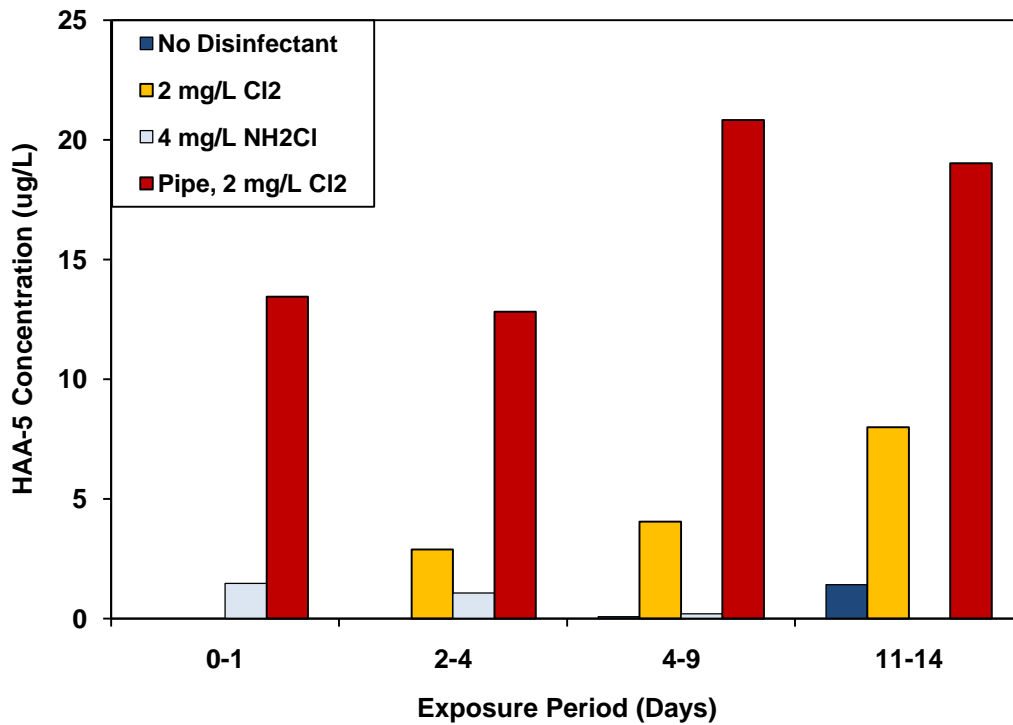
Figure II-21. HAA-5 concentrations (ug/L) as a function of time for all three water treatments and aged pipe sample

Consistent with the THM data, the highest overall concentrations of HAAs were found in chlorinated waters, although statistical analysis found statistically greater concentrations only when compared with no disinfectant water ($p = 0.045$, one-sided paired t test), not with chloraminated samples ($p = 0.1104$)

The data confirm the potential for TOC leached from epoxy to react with disinfectant (particularly chlorine) to form HAAs as well as THMs. Given the high amount of TOC leached, HAA concentrations remained considerably low and the impact of epoxy on HAA formation appears to be low.

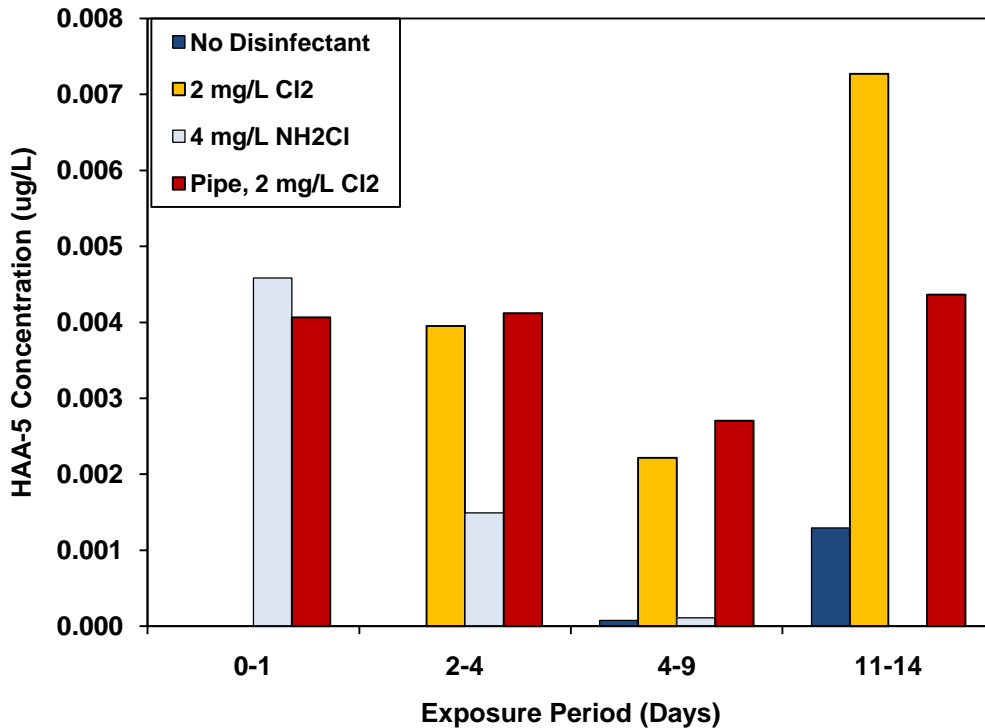
Figure II-22. HAA-5 formation rate (ug/cm²/d) as a function of time for all three water treatments and aged pipe sample

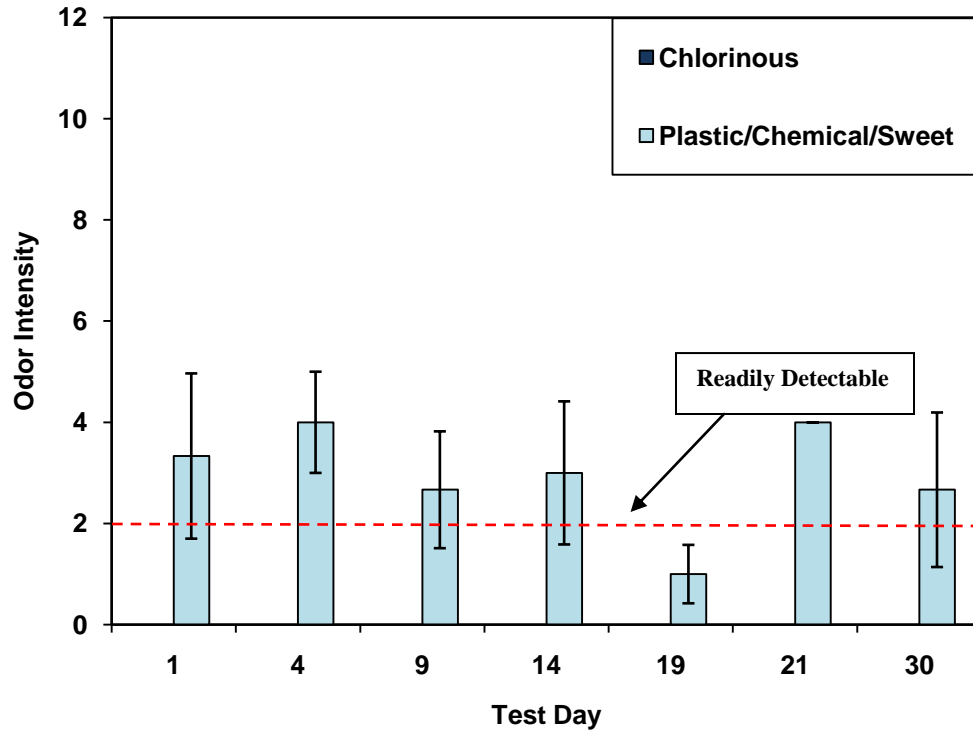
Figure II-23. Odor descriptors and intensities for no disinfectant samples as a function of time; error bars indicate standard deviations

The odor intensity from all three samples would exceed the FPA readily-detectable threshold of 2 and would likely warrant complaints from customers. Flushing the pipes would certainly decrease the intensities but the results do show that, given stagnant conditions and high disinfectant concentrations (particularly chlorine), odor may be problematic.

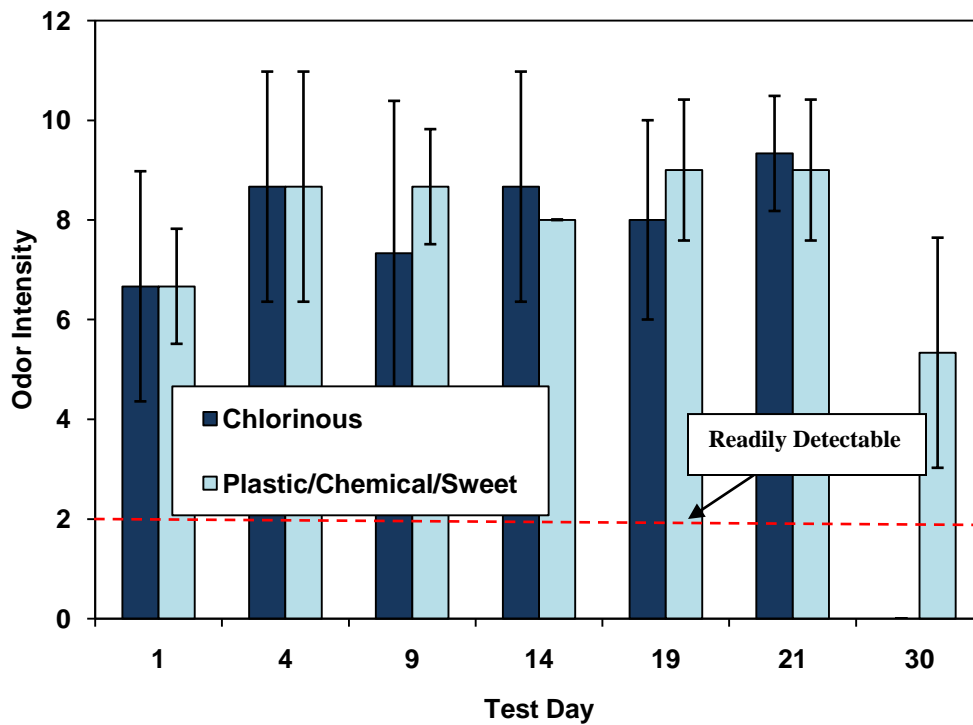
Figure II-24. Odor descriptors and intensities for chlorinated samples as a function of time; error bars indicate standard deviations
