Impact of an Epoxy Pipe Lining Material on Distribution System Water Quality

Thesis submitted to the faculty of the Virginia Polytechnic Institute and State University in
partial fulfillment of the requirements for the degree of
Master of Science in Environmental Engineering

Key words: epoxy, in situ lining material, drinking water quality

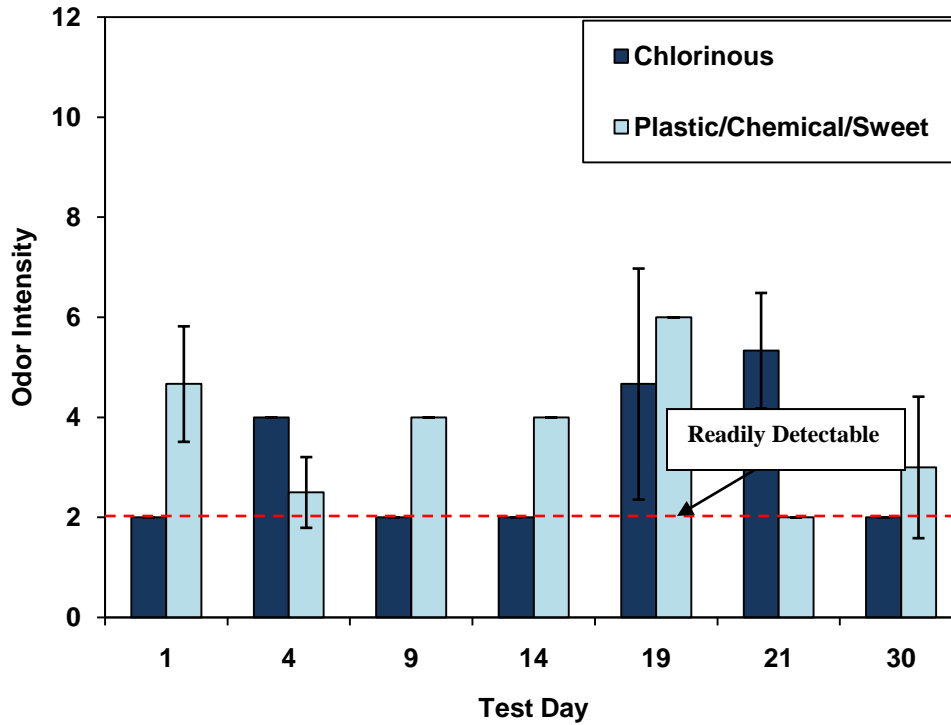
Figure II-25. Odor descriptors and intensities for chloraminated samples as a function of time; error bars indicate standard deviations

Panelists reported the chloraminated test waters also had both a chlorinous and plastic/chemical odor, but with weaker intensities of both chlorine and plastic. The chlorinous odor appeared to be masked by the plastic/chemical odor on Day 1 and had a much lower intensity than in chlorinated test waters, averaging only 2.7 over the study. The plastic/chemical odor was also not as intense as in chlorinated test waters, averaging 4.4, and panelists frequently described the odor as sweet and pleasant. The sweet descriptor was also commonly used to describe the chloraminated control water, most likely due to chloramines having a characteristically sweeter odor. Data is shown in Figure II-25.
